ANALYSIS, INSPECTION, AND REPAIR METHODS
FOR
PIN CONNECTIONS ON
ILLINOIS BRIDGES

ILLINOIS DEPARTMENT OF TRANSPORTATION
BUREAU OF MATERIALS AND PHYSICAL RESEARCH
APRIL 1992

16. Abstract This report documents methods used in Illinois for analysis, inspection, and repair of pin connections in bridges. Weldable foil strain gages were used to detect the effects of unknown levels of fixity in pins on cantilever truss bridges. Other methods for detecting pin movement, including electronic angle sensors and scratch-type pointer gages were also investigated. The maximum effect of complete fixity on pins and hangers was estimated with finite element models of both cantilever truss and cantilever girder bridges. A pin inspection procedure using ultrasonic instrumentation was developed and tested throughout the state. Design deficiencies of pin connections are noted. Modernized details which eliminate many of the existing deficiencies are presented. The improvements include better tolerances on fits and finishes, increased degrees of freedom of rotation, provisions for periodic lubrication, high strength, corrosion resistant alloys, extreme pressure lubricants, and toughness requirements bas

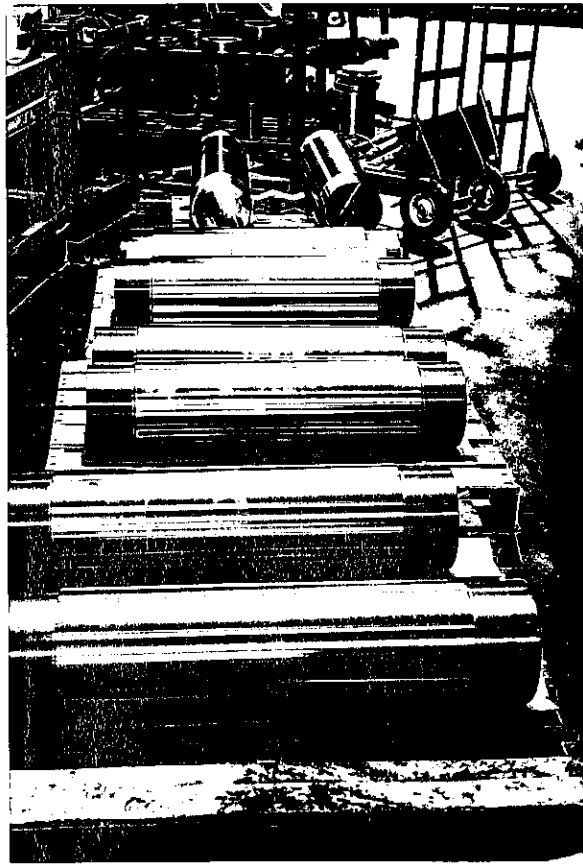
Figure 27. Machined and finely ground pins for Peru Bridge.

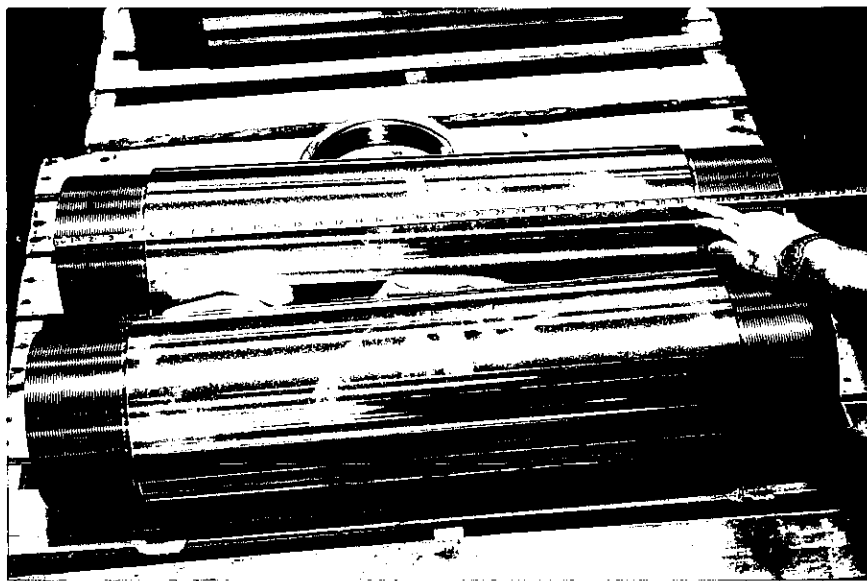
Figure 28. Closeup of pin and general size.

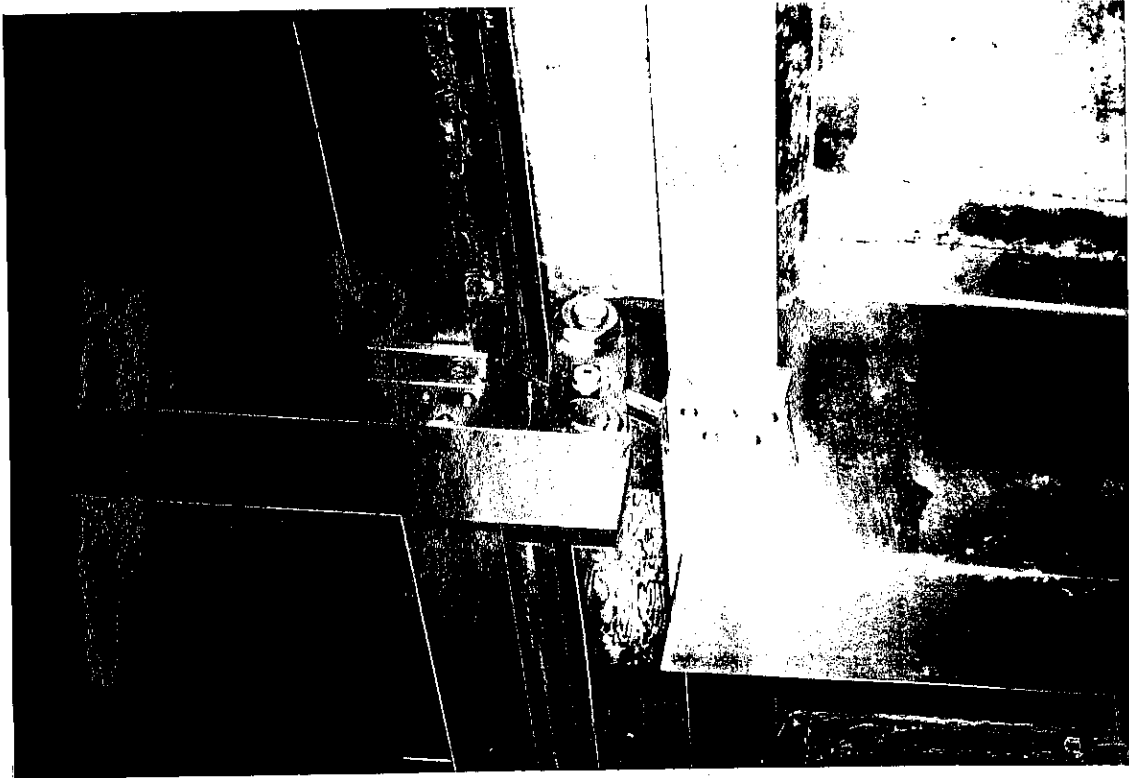
Figure 6. Photograph of an electronic angle sensor installed on Hazel Dell Road over I-55 in Springfield.

The electronic rotation sensors were also able to provide meaningful information, although less so than the strain gages. The question of rotation is answered, but further stress analysis is more difficult. Electronic rotation sensors are also much more expensive than strain gages. The "quick-stop test" method did not work, probably because the vehicle was too light and could not induce movement. Electronic rotation sensors are not recommended for general application but are useful for spot checks for thermal movement, especially at trouble spots on cantilever girder bridges.
